# TheAccessOfficer Case Studies

## CS2 North Somerset Town Hall, Weston-super-Mare

### Access to a civic building

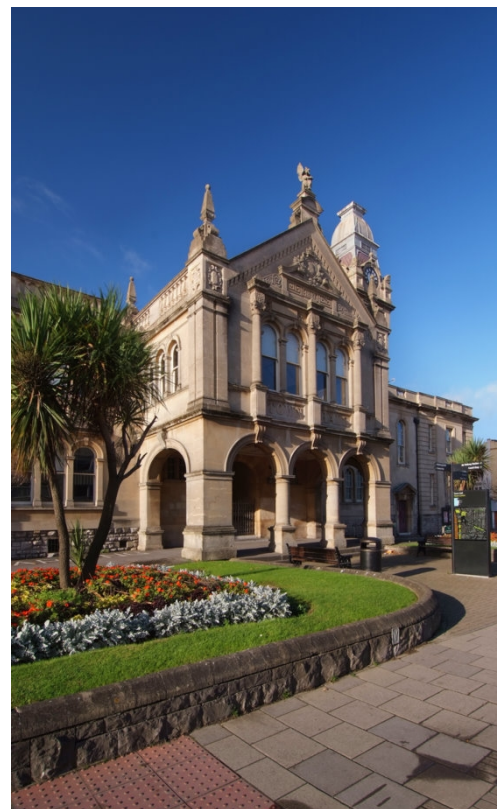
The design solution was not to construct a large ramp which would have posed major design, cost and heritage problems and also have closed off the use of the actual portico. Instead, the steps were re-built to conceal a platform lift. Manufactured by [Sesame Access](#), the left half of the steps (see picture) slides back to reveal the lift built into the ground at the foot of the steps. It then operates like any normal platform lift.

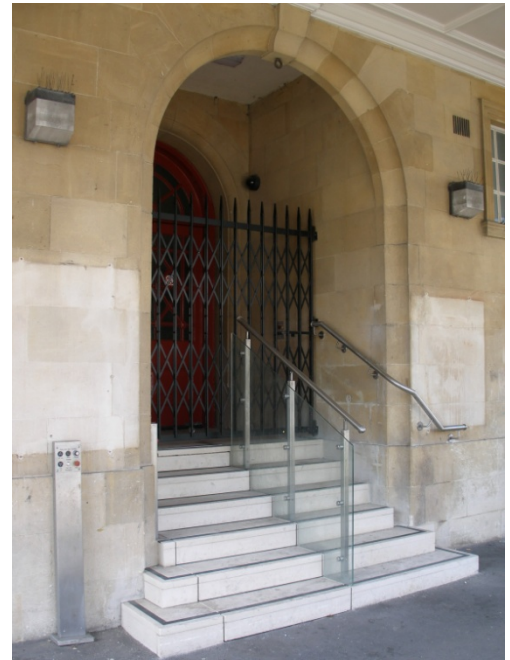
The entrance in step configuration

- Retained an improved flight of steps with handrails and highlighted tread nosings for disabled people who preferred them
- Installed a lift to overcome the flight of steps for wheelchair users
